MANDATORY SERVICE BULLETIN

Service Bulletin No. 366B
(Supersedes Service Bulletin No. 366A)
Engineering Aspects are
FAA Approved

SUBJECT: Carburetor Throttle Body Screw Inspection

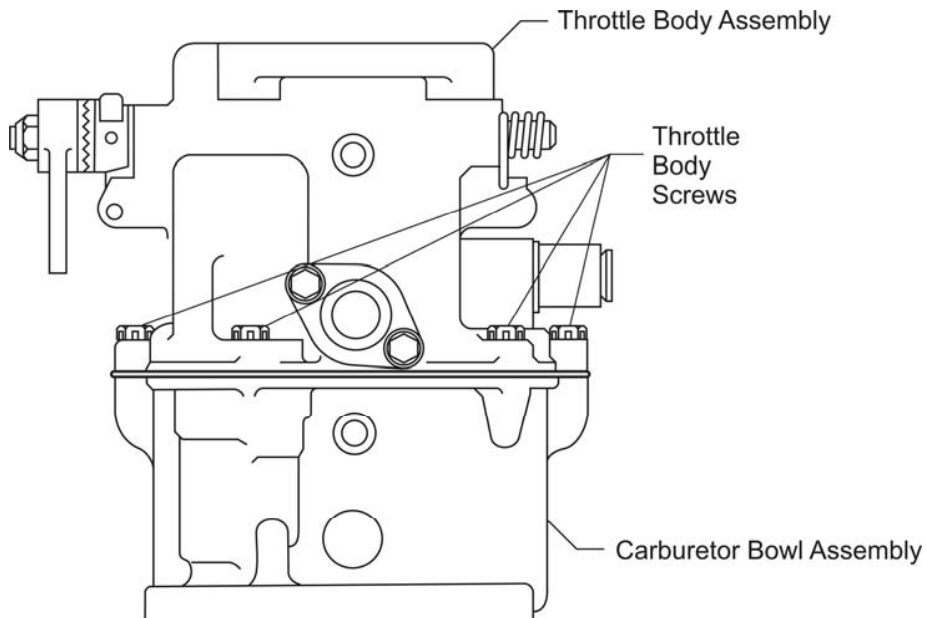
Figure 1. Illustrative Example of Throttle Body Attaching Screws

Instances have been reported of leakage through the gasket between the bowl assembly and throttle body of the carburetor, evidenced by fuel stains in the area of the leak. Leakage of this type may be accompanied by loose screws that attach the bowl and throttle body.

See Figure 1 for illustrative example of the throttle body attaching screws.

Models MA-3A, MA-3PA, MA-3SPA, and MA-4SPA have four screws. Models MA-4-5, MA-4-5AA, and MA-6AA have six screws.

1. Check the carburetor for evidence of fuel stains on the outside of the bowl along the parting line.
2. Check for movement between the throttle body and bowl.
3. Check each throttle body to bowl attaching screw for looseness by attempting to move the screw and/or locktab washers with your fingers.

4. If there is evidence of fuel stains, movement between the throttle body and bowl, or the throttle body to bowl attaching screws are loose then remove the carburetor in accordance with the applicable engine and airframe service manuals. Send the carburetor to a qualified repair station for troubleshooting and repair. For the most recent listing of qualified repair stations contact Volare Carburetors at the following:
